Residential Condition Assessment

PROJECT FILE NO.
16801

Chao James Tseng Hui
4032 Leon Drive
Plano, Texas 75074

March 21, 2016

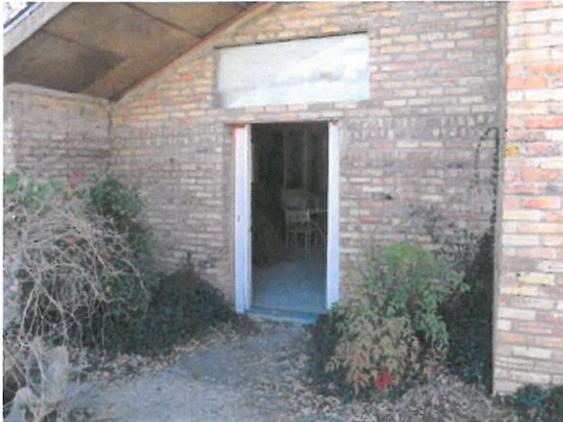
- The front entry was extended with modifications to the existing masonry courtyard walls and roof (**Figure 3**);
- The glazing over the front entry was not set in a window frame (**Figure 4**);

Figure 3: Renovated extended front entrance on north elevation

- Improperly installed glazing above the front entry requires replacement with a complete window assembly;
 - The brick masonry courses added to the previous screen walls are poorly constructed with various thicknesses of mortar joints and have questionable structural integrity;

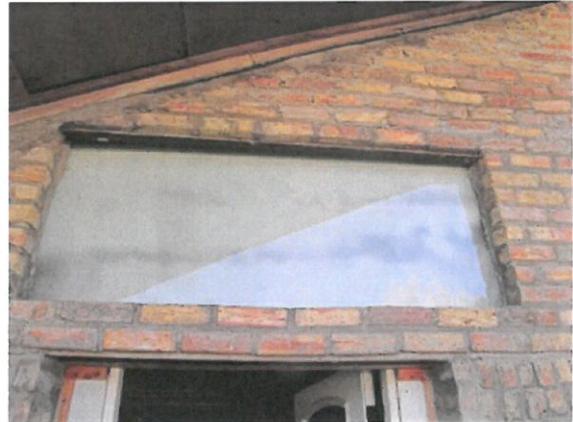
Figure 4: Glazing without window frame over front entrance

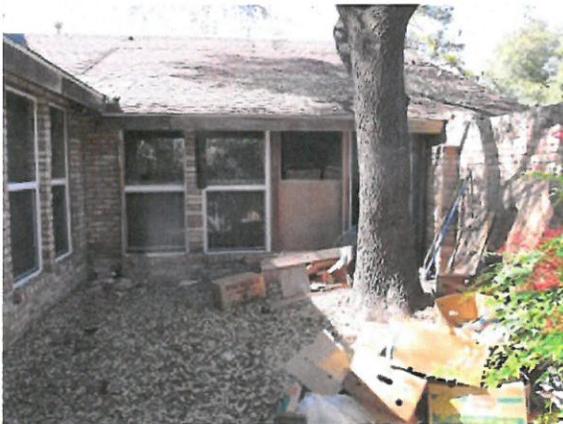
- The modified roof at the north elevation was visible from the courtyard east of the front entry (**Figure 5**);
- The east elevation was missing wood siding and had exposed sheathing (**Figure 6**);

Figure 5: Courtyard at front entrance; modified roof over front entry

- The windows at the courtyard side of the front entry expansion are improperly installed, including a lack of flashing;

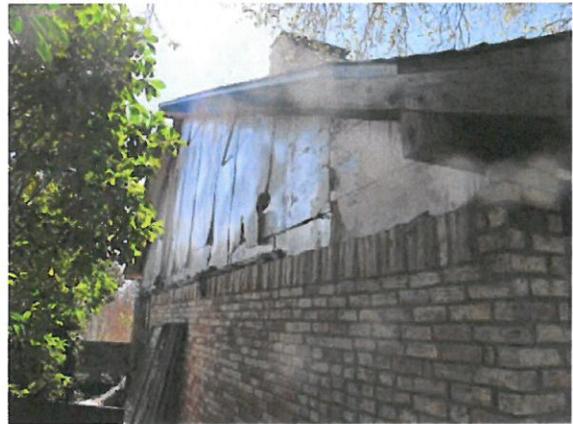
Figure 6: East elevation with missing wood siding

- The exterior of the residence is in disrepair from either incomplete construction or lack of maintenance:
 - Wood siding has deteriorated and requires replacement;

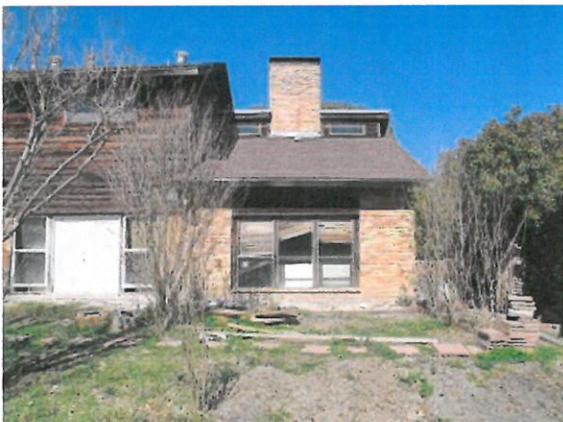
- The south elevation had deteriorated wood siding. Brick veneer was missing and exposed sheathing was visible (**Figure 7**, **Figure 8**, **Figure 9**, and **Figure 10**);

Figure 7: Partial south elevation at east corner

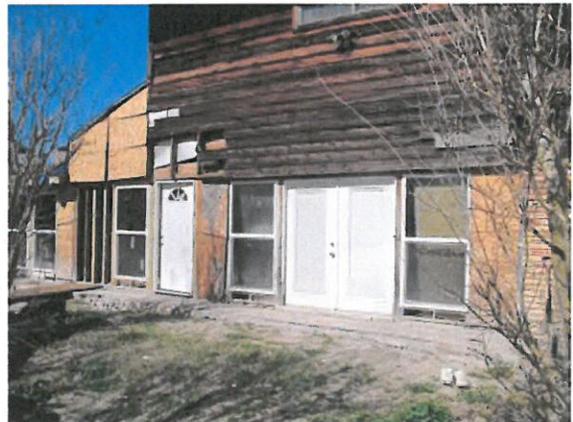
Figure 8: South elevation

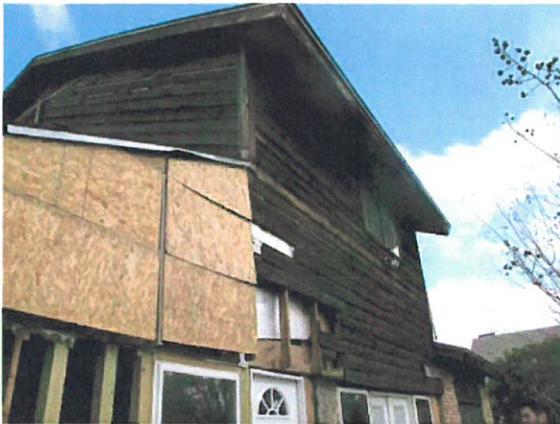
Figure 9: Deteriorated wood siding; exposed wall sheathing

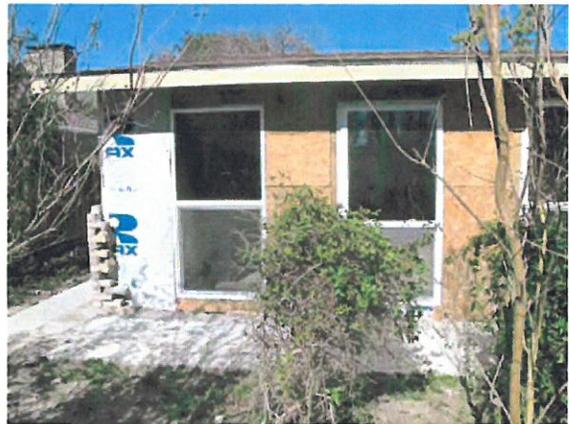
Figure 10: Exposed wall sheathing

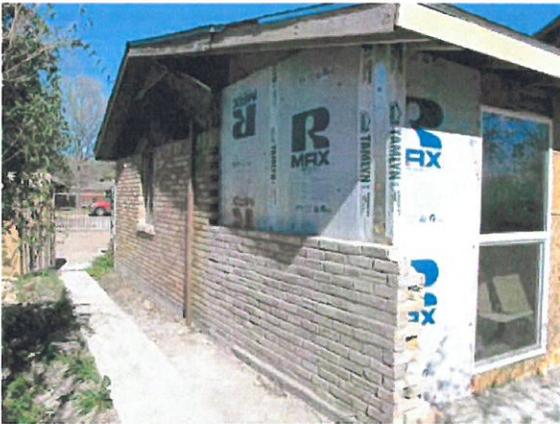
- The west elevation was missing brick veneer and had exposed sheathing (**Figure 11**);
- At the west elevation, near the garage, the brick veneer was distressed (**Figure 12**);

Figure 11: Partial west elevation with exposed wall sheathing

- The upper section (above the masonry veneer) of the west wall is incomplete, missing a proper weather barrier, flashing and exterior finish material;

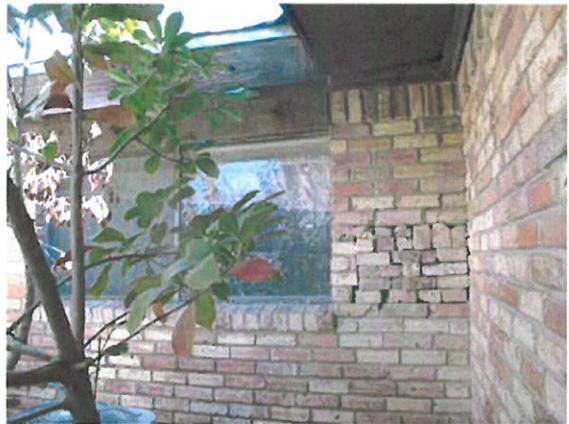
Figure 12: Brick veneer distress

- The roof/wall intersection weather barrier at the south elevation requires completion;
 - Brick veneer at the west wall near the garage requires repair;

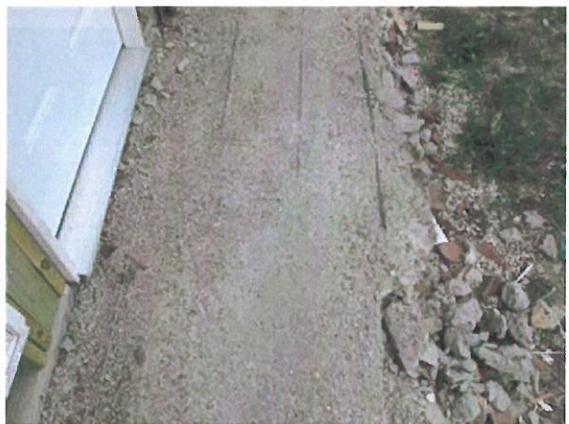
- The garage entry was located at the west elevation near the front of the residence (**Figure 13**);
- A concrete sidewalk along the south elevation was constructed with reinforcement exposed near the surface (**Figure 14**);

Figure 14: Exposed reinforcement in concrete sidewalk

- The sidewalk constructed at the south elevation is of poor concrete quality and has exposed reinforcing steel at its surface;
- Trees in close proximity to the residence require trimming and previously cut down trees require exposed stumps to be removed;

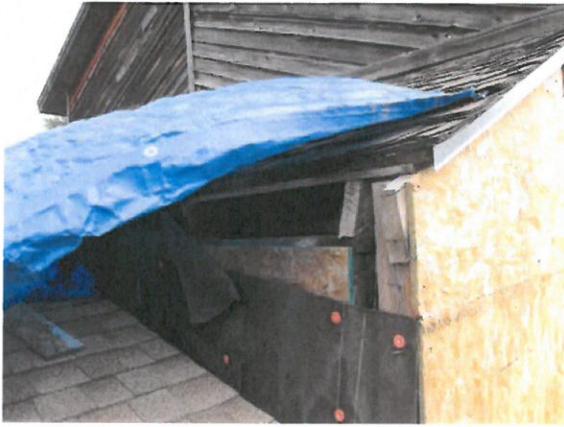
Figure 15: incomplete second story wall construction

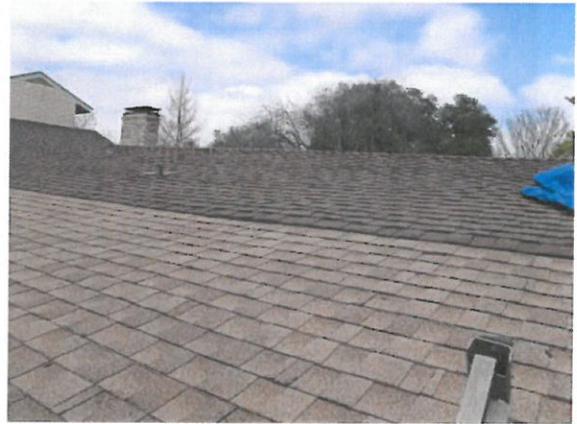
- Gutters and downspouts were not installed;
- Composition shingles were installed over a previous roof constructed of wood shakes;
- The roof/second story wall modifications were not completed at the south elevation (**Figure 15**);
- A different color composition roof was installed over the modified patio space at the south elevation (**Figure 16**);

Figure 16: Different colored roof shingles

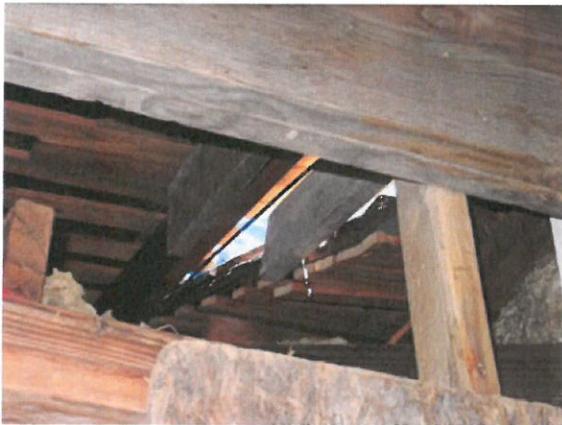
- Incomplete wall/roof construction at the modified patio space caused openings in the weather barrier (**Figure 17**);
- Due to the unfinished ceiling construction, wood shakes were visible at the roof framing (**Figure 18**);
- Modified structural framing, including roof framing, beams, and bearing wall framing were visible in the modified patio space (**Figure 19** and **Figure 20**);
- The majority of spaces at the interior of the first floor were under construction or re-construction (**Figure 21**, **Figure 22**, **Figure 23**, and **Figure 24**);
- The original front entry was extended to the original front courtyard walls. New and modified roof, ceiling, and wall framing was installed (**Figure 25**, **Figure 26**, and **Figure 27**);
- Termite damage was evident in the wood framing (**Figure 28** and **Figure 29**);
- The second floor rooms were not accessible;

Figure 17: Incomplete roof/wall construction

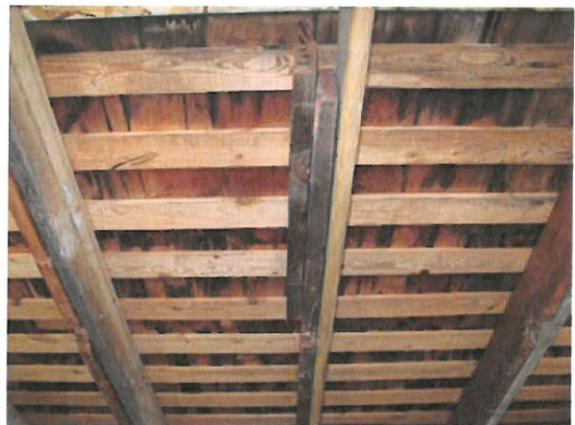
Figure 18: Wood shake roof under composition shingles at patio; modified roof framing

- Composition roof shingles have been installed over a wood shake roof system;
- The soffits are in disrepair and require replacement;
- The interior of the residence is in disrepair from incomplete construction:

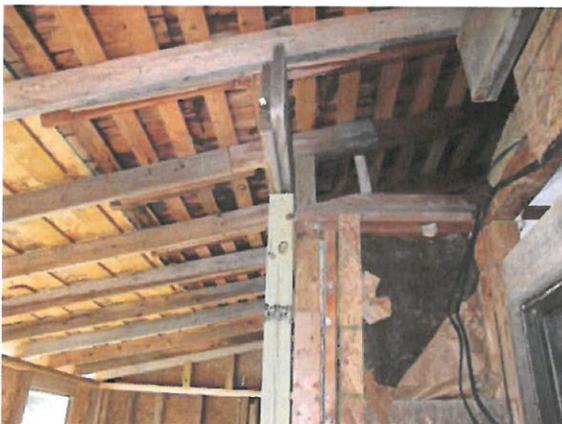
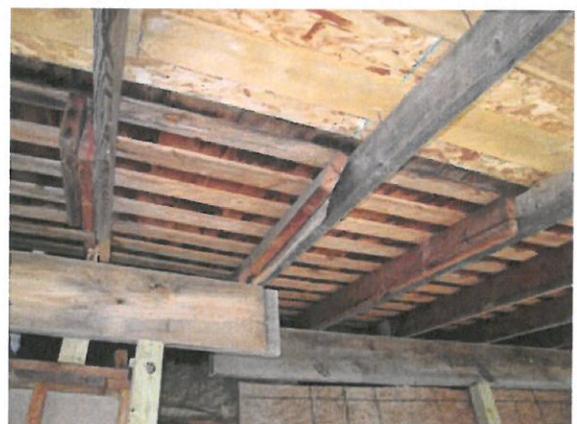
Figure 19: Modified roof framing, beams, and bearing wall framing

Figure 20: Modified roof framing, beams, and bearing wall framing

- Structural elements:
 - The roof framing and the supporting beams and bearing walls in the enclosed patio are improperly constructed and pose a life safety concern. The existing roof framing has been raised to change the roof slope and allow for clearance height at the exterior wall by modifying the interior bearing elements. New wood beams, posts, and wall studs have been added, but are not properly integrated for structural stability. The roof framing has been extended by splicing new wood rafters to the existing rafters with nailed wood splices. All these modifications pose a life safety concern;

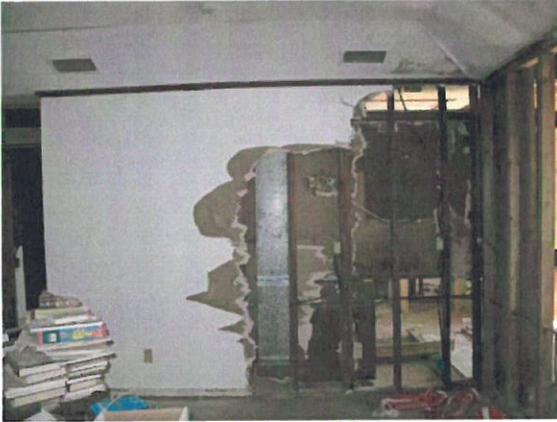
Figure 21: Partial gypsum board walls and exposed wall framing

- The interior walls under modification are incomplete, lacking gypsum board with finishes, door installation, and trim at doors, ceilings, and floor;

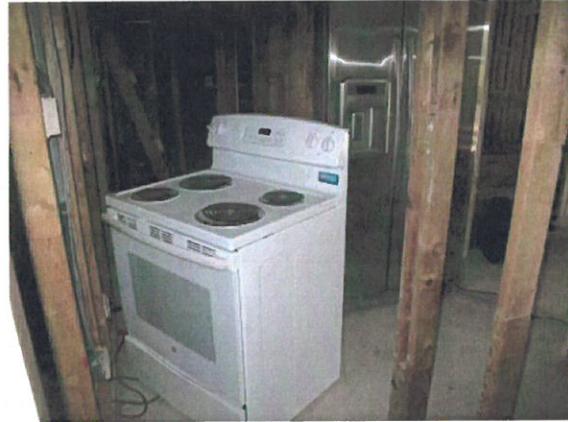
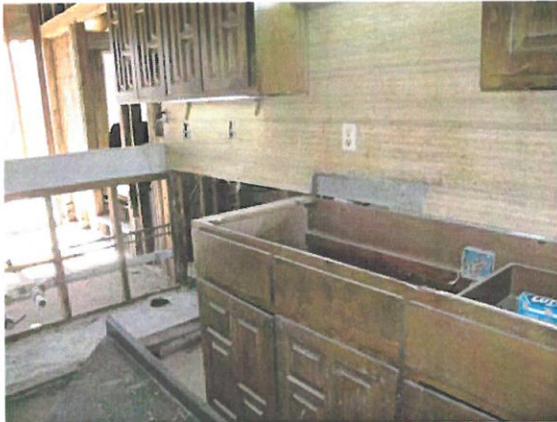
Figure 22: Incomplete construction in kitchen

Figure 23: Incomplete construction in kitchen

- The ceilings are incomplete, lacking insulation and sheet rock with finishes;
 - Floor finishes are incomplete;
 - The modifications to cabinets in the kitchen and bathrooms are incomplete;

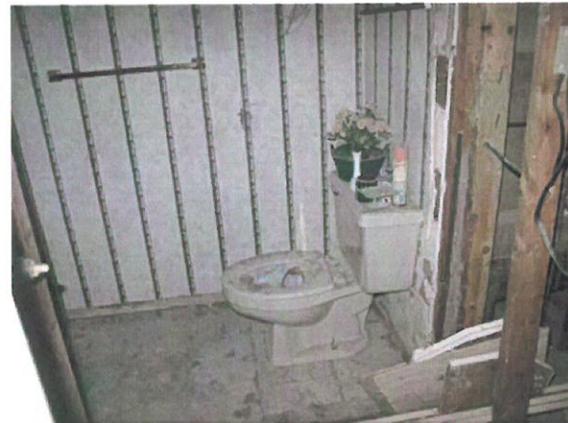
Figure 24: Partially finished bathroom

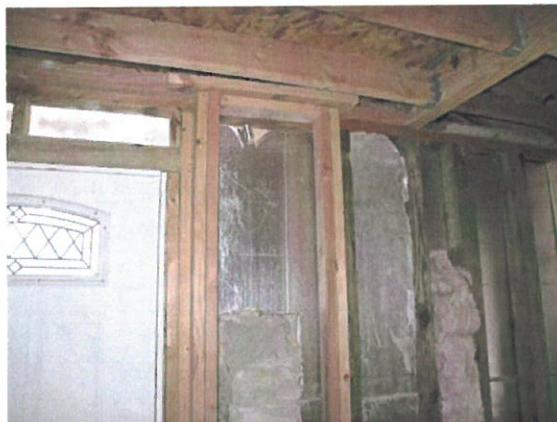
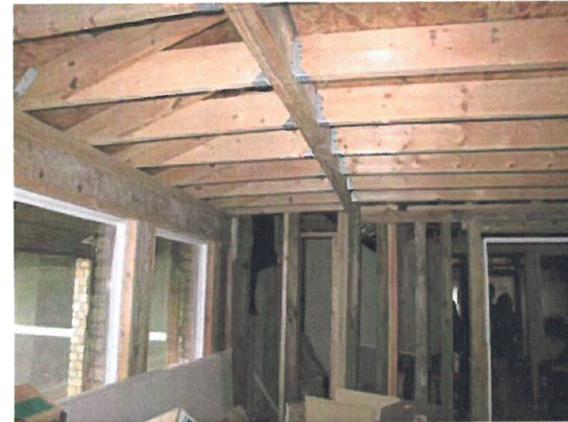
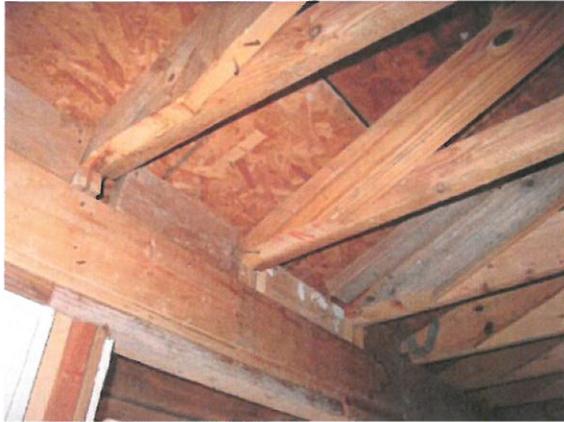
Figure 25: New ceiling and wall framing at extended front entry room

Figure 26: New ceiling and wall framing at extended front entry room

Figure 27: New ceiling framing at extended front entry room; modified roof rafter bearing ends

- The existing roof framing has been modified to accommodate the extended front entry. A new ceiling has been framed in this area with non-standard framing techniques and pose a life safety concern;

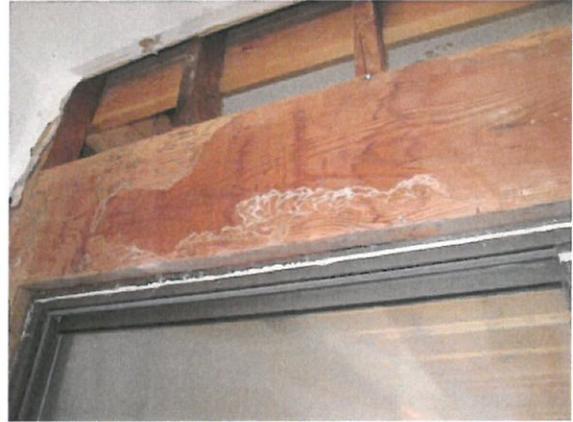
Figure 28: Termite damage at wood header

- Termite damage is visible which causes concern for the overall structural integrity of the wood framing;

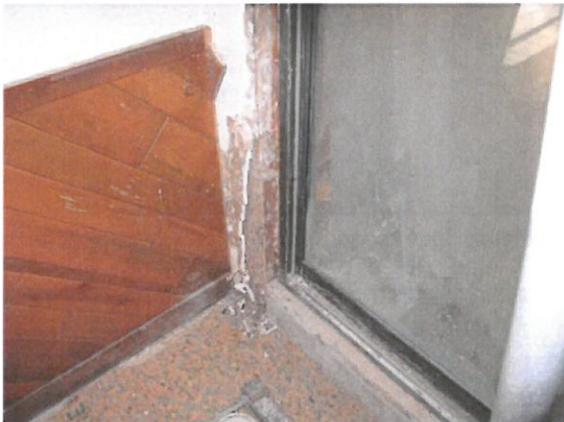
Figure 29: Termite damage at wood studs

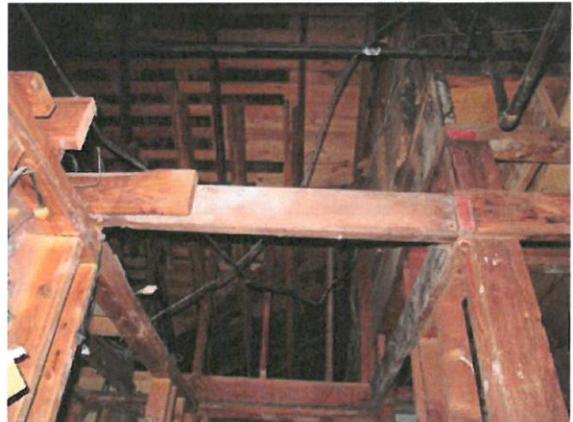
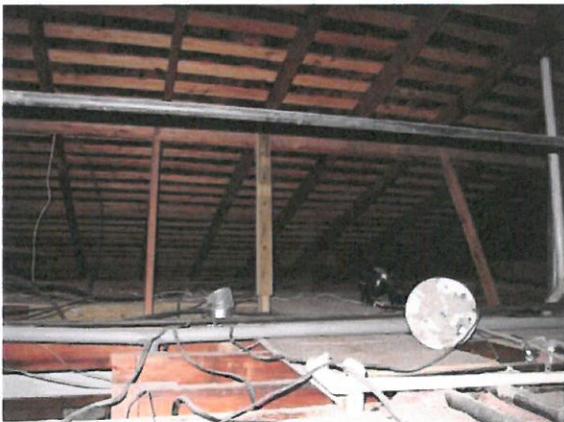
- Roof framing was modified in areas (**Figure 30** and **Figure 31**);
- A mechanical system for the residence was not installed (**Figure 32**).

Figure 30: Attic framing

Figure 31: Attic framing

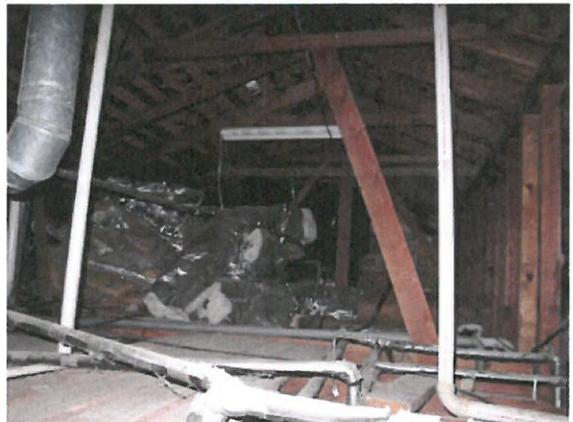
Figure 32: Flex ductwork debris in attic

- A mechanical system for conditioning the space was not observed. A previous system has been installed in the attic, but is no longer present;
- Electrical wiring is exposed and loosely attached in the areas of renovation. Light fixtures are unattached and dangling in some areas;
- Plumbing pipes are exposed in the areas of renovation. Plumbing fixtures are detached in some areas.

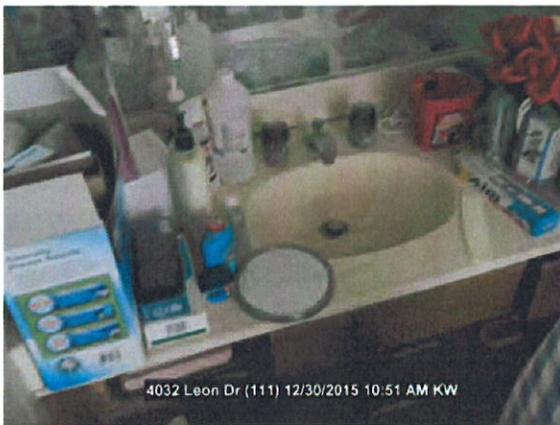
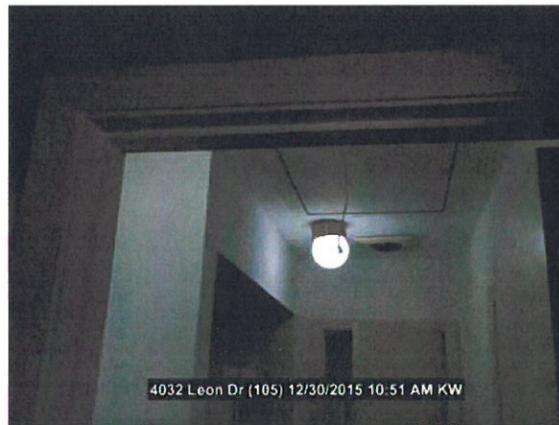
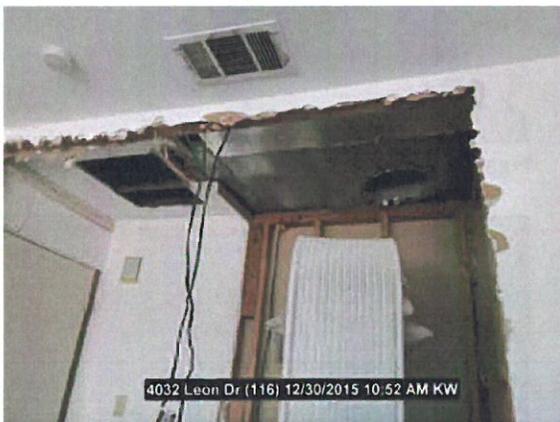
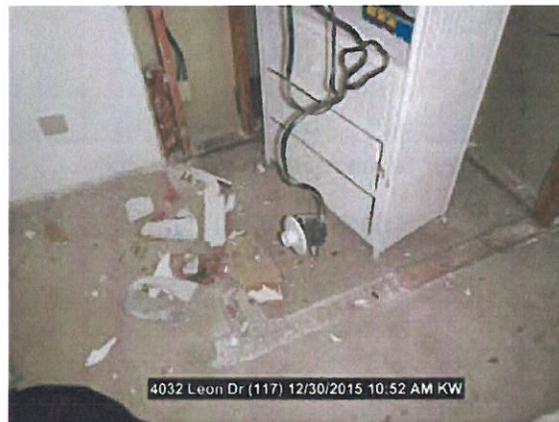
The photos of the second floor living spaces taken by Kyle Watson, Property Standards Specialist, City of Plano, indicated that, in addition to the first floor, modifications to the second floor had also been initiated. The spaces were more complete than the first floor, and architectural and structural modifications had been initiated (**Figure 33** to **Figure 36**).
