Residential Condition Assessment

PROJECT FILE NO.
16801

Chao James Tseng Hui
4032 Leon Drive
Plano, Texas 75074

March 21, 2016

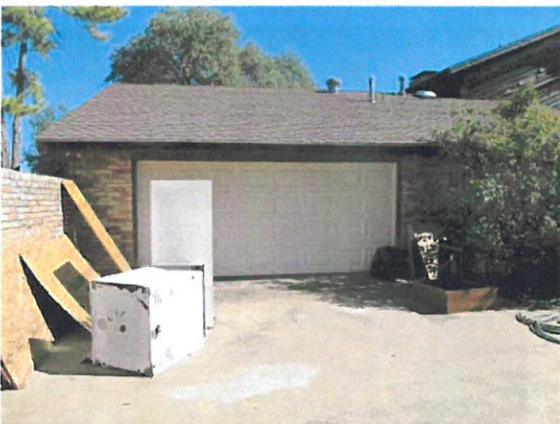
Figure 13: Garage entry at west elevation

- The garage entry was located at the west elevation near the front of the residence (**Figure 13**);
- A concrete sidewalk along the south elevation was constructed with reinforcement exposed near the surface (**Figure 14**);
